Manhole Inspection Summary

Manhole # S17II_016MH

Insp Date: **6/12/07 9:39 AM**

Location Address: **2201 PRESBURY ST**

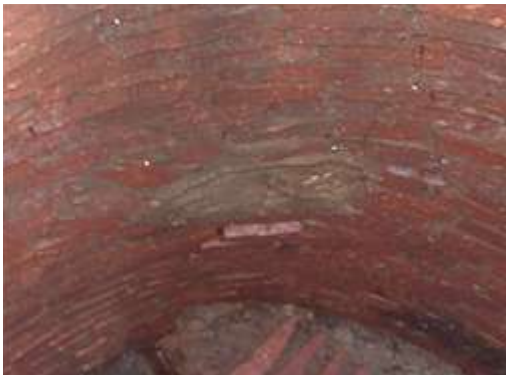
Defect 4

Condition: ☐ Sound ☐ Cracked ☐ Root Intrusion ☒ **Loose Brick** ☐ Deteriorated

LOOSE BARREL BRICKS

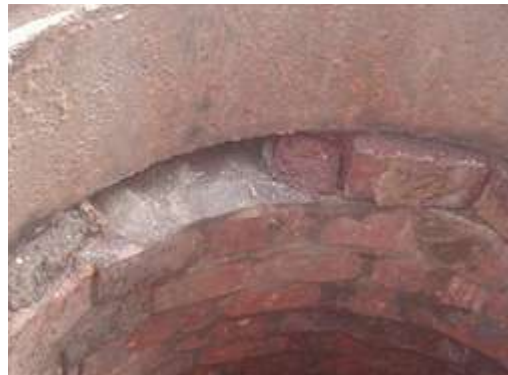
Defect 3

Condition: ☐ Sound ☐ Cracked ☐ Root Intrusion ☐ Loose Brick ☒ **Deteriorated**

CHIMNEY DETERIORATION OF
CHIMNEY

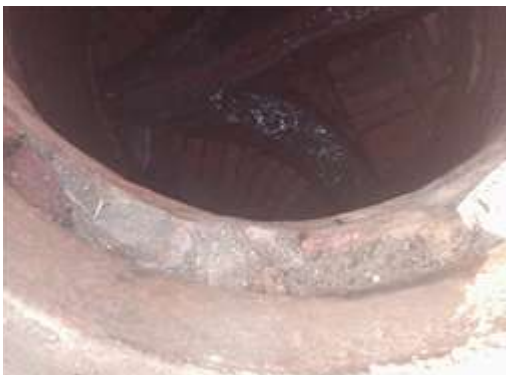
Defect 2

Offset: **3** (in.)

FRAME OFFSET

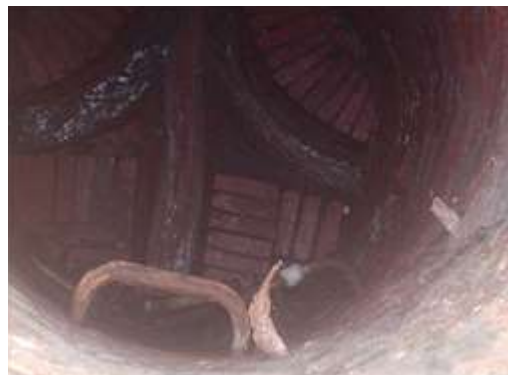
Defect 1

Count: **4** Missing: **1** ☒ **Corroded**

MISSING AND CORRODED STEPS
